Natatoriums:

What Can Go Wrong—and Did

'Value engineering,' lack of preventive maintenance, and Mother Nature undermine otherwise state-of-the-art Florida health club

By **MIKE WEST, PHD, PE**
Advantek Consulting Inc.
Melbourne, Fla.

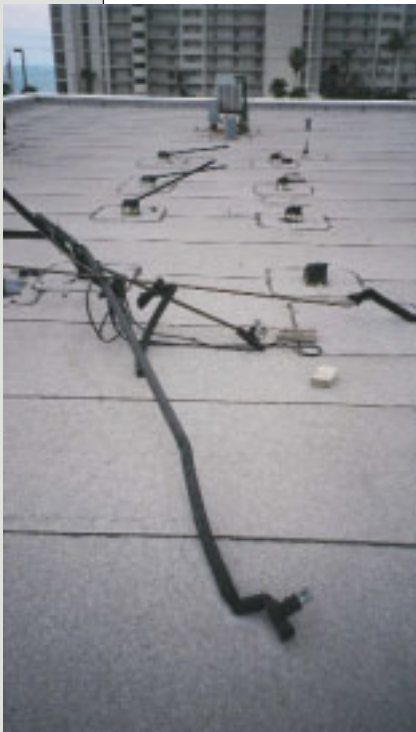
Remnants of piping and support brackets where solar hot-water panels were destroyed by Hurricane Francis in September 2004. The panels damaged the roof deck and one of the condenser coils as they were blown across the roof.

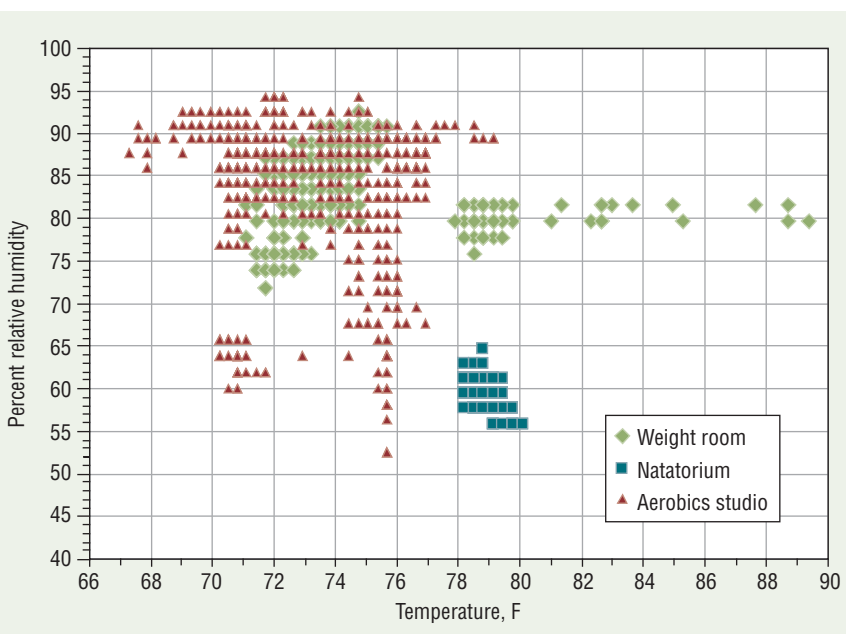
Air-handling-unit inlet conditions.

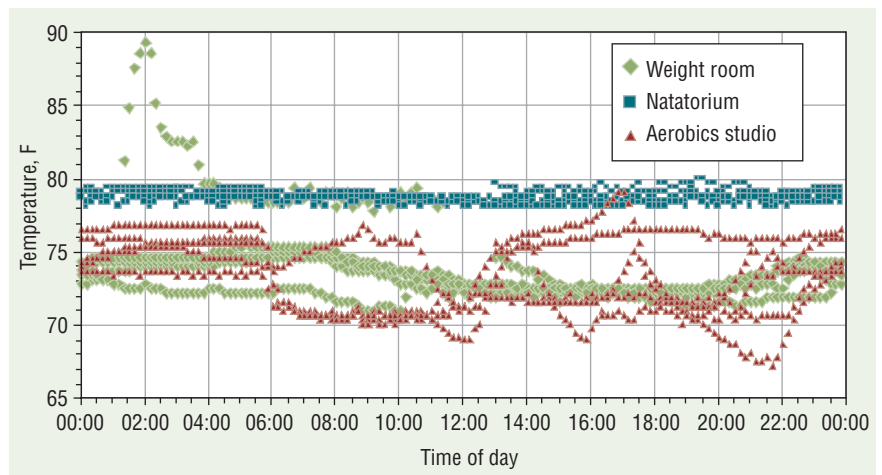
Air-handling-unit inlet temperature vs. time of day.

and aerobics studio. A rusted damper in the outside-air unit resulted in insufficient ventilation airflow and negative pressure. Trend data showed that while the natatorium conditions were well-maintained at the desired set point (79 F, 60-percent relative humidity), a significant quantity of humid pool air was being drawn into the adjacent air-handling returns because of the pressure imbalance. Because of the transfer of pool air, trend logs showed weight-room and aerobics-studio AHU-inlet conditions to be much more humid than the general space conditions (actual space conditions in those areas were within the comfort range). While no mold growth was observed, there were signs of con-

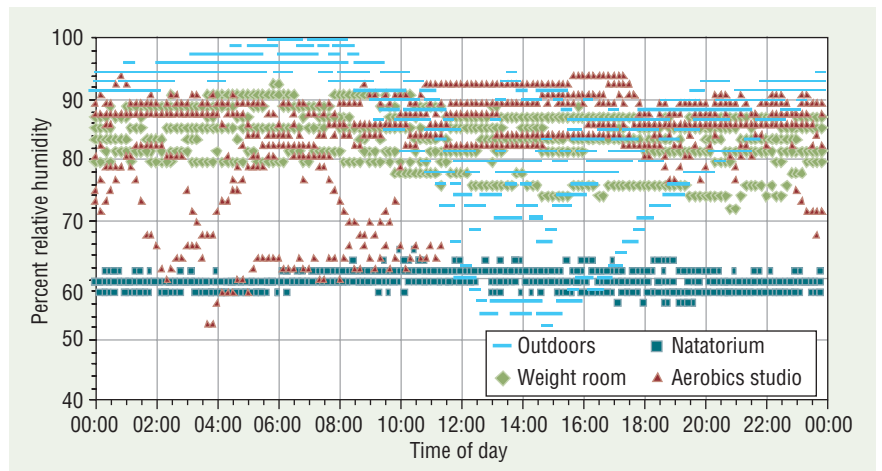
Air-handling-unit inlet humidity vs. time of day.
